The Crack and Seat Method of Pavement Rehabilitation

Final Report

PHYSICAL RESEARCH REPORT NO. 104 / JULY 1988

Illinois Department of Transportation
Bureau of Materials and Physical Research

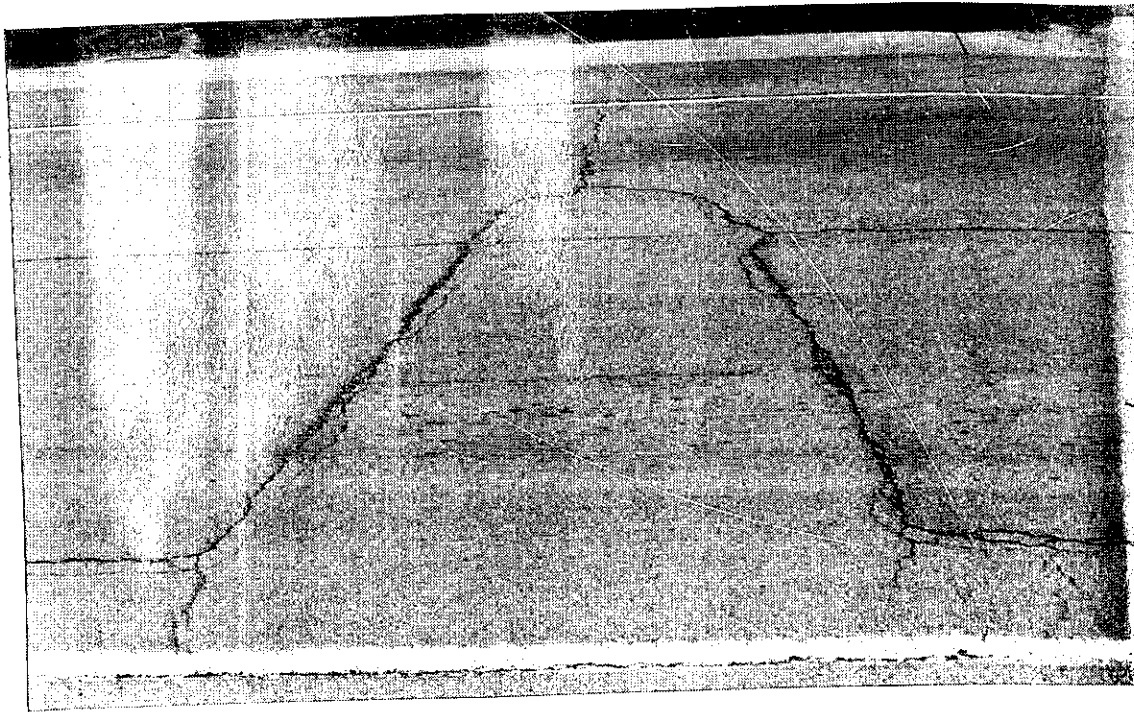
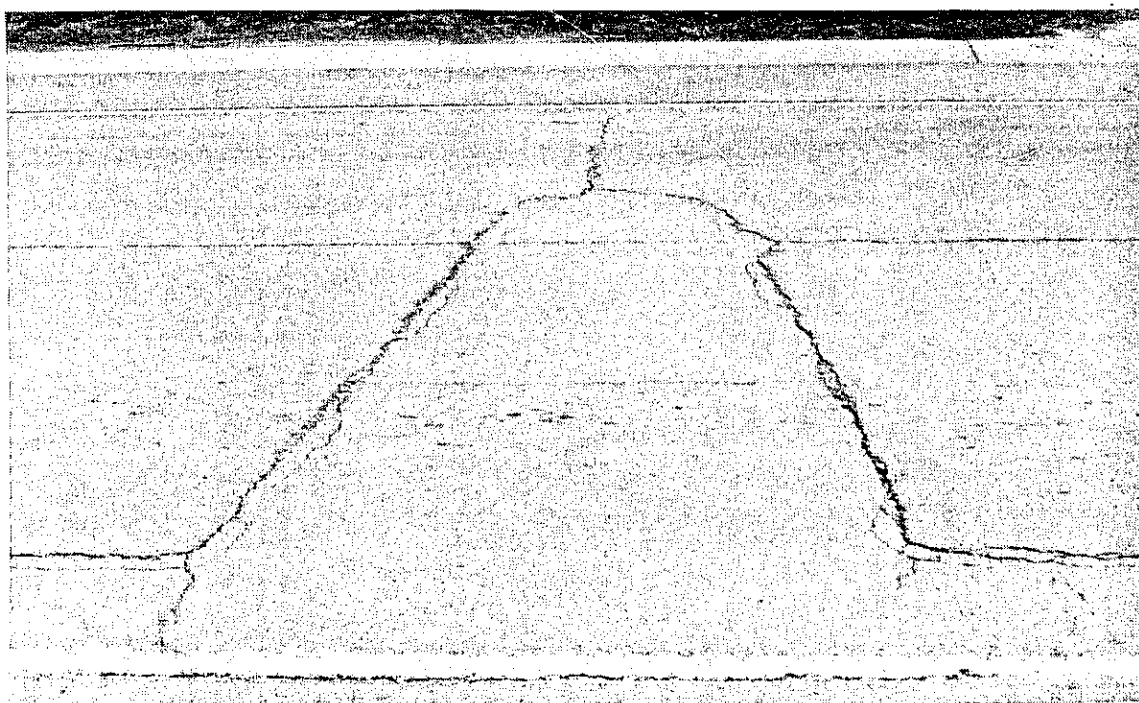
that there is less transverse and widening cracking present in the crack and seat sections than in the control sections. The majority of patches are reflecting through the overlay in the control sections, as shown in Figure 10. While there is more longitudinal midlane cracking in the crack and seat section, it appears to be a result of mix segregation in the paver auger during laydown.

FIGURE 10: PATCH REFLECTED THROUGH 3-INCH CONTROL
SECTION ON ILLINOIS ROUTE 97

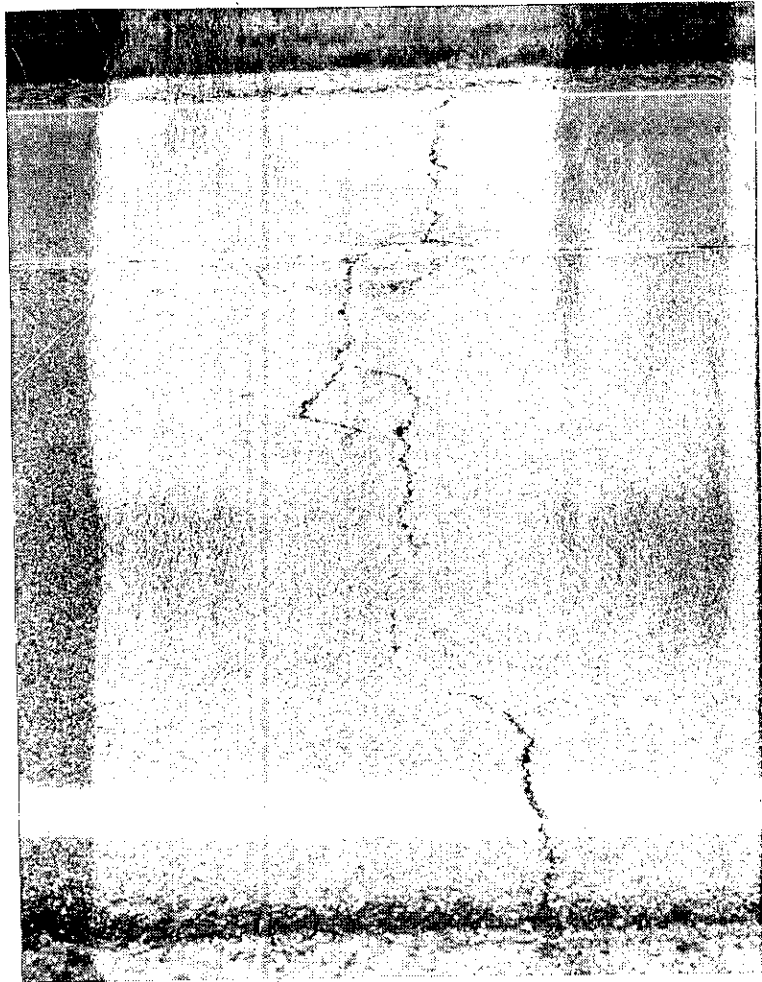
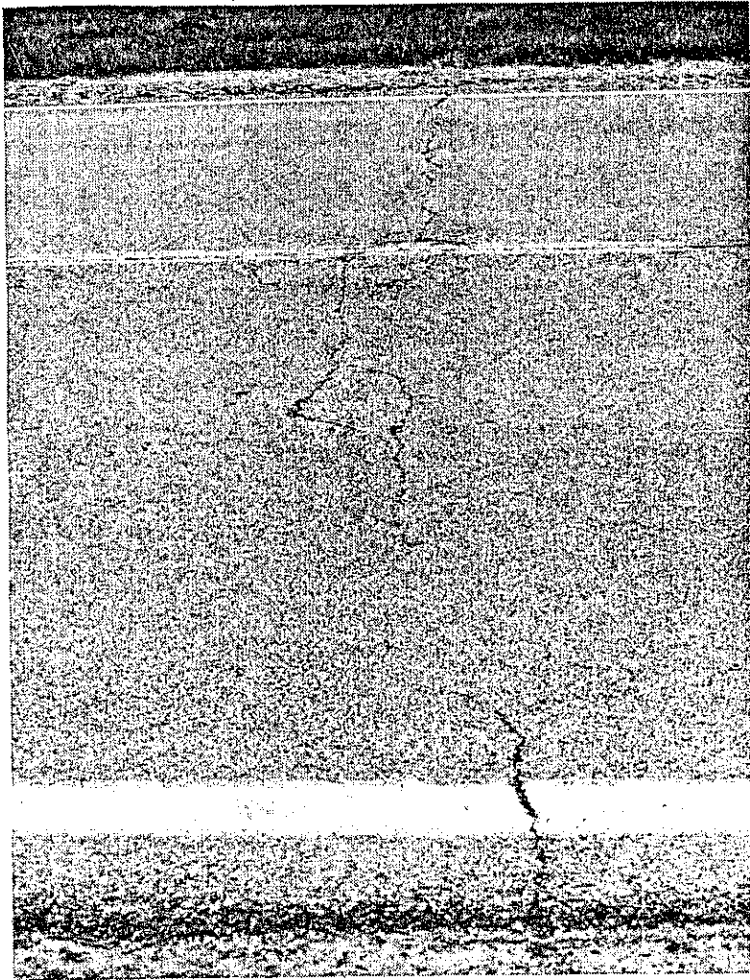
At first glance, Illinois Route 97 seems to be the poorest performing section. After four years in service, transverse and longitudinal cracking are present in both the crack and seat and control sections, as can be seen in Figures 10-12. However, Table 3 and Figure 13 do show

FIGURE 11: TRANSVERSE
CRACKING IN 3-INCH CRACK
AND SEAT SECTION ON
ILLINOIS ROUTE 97

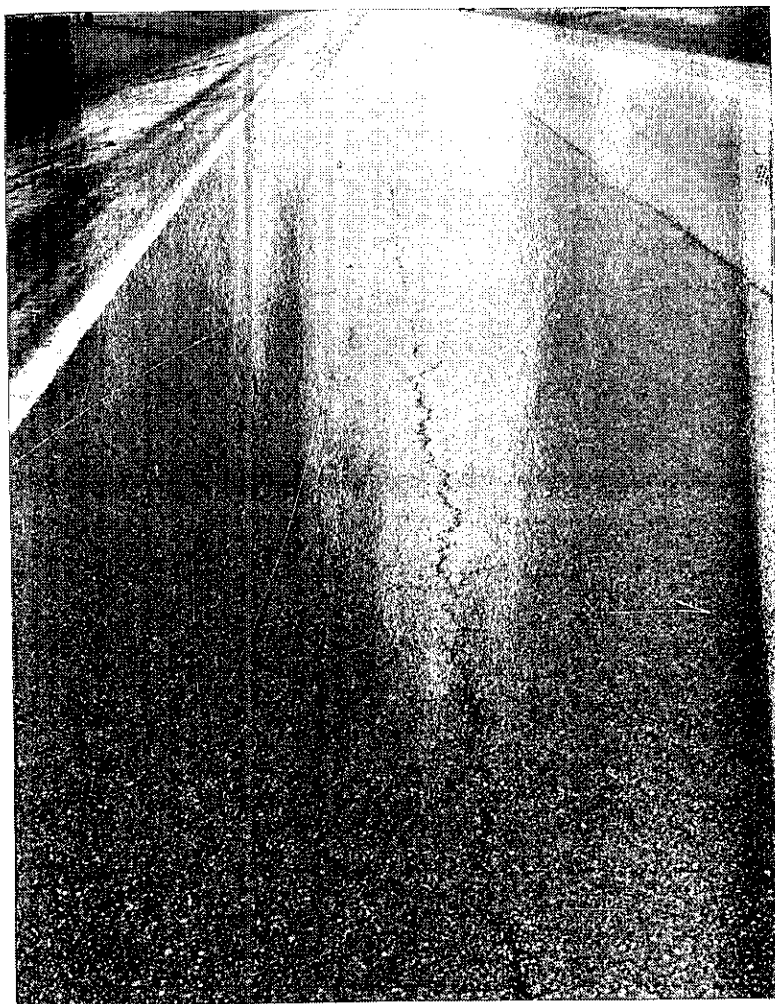
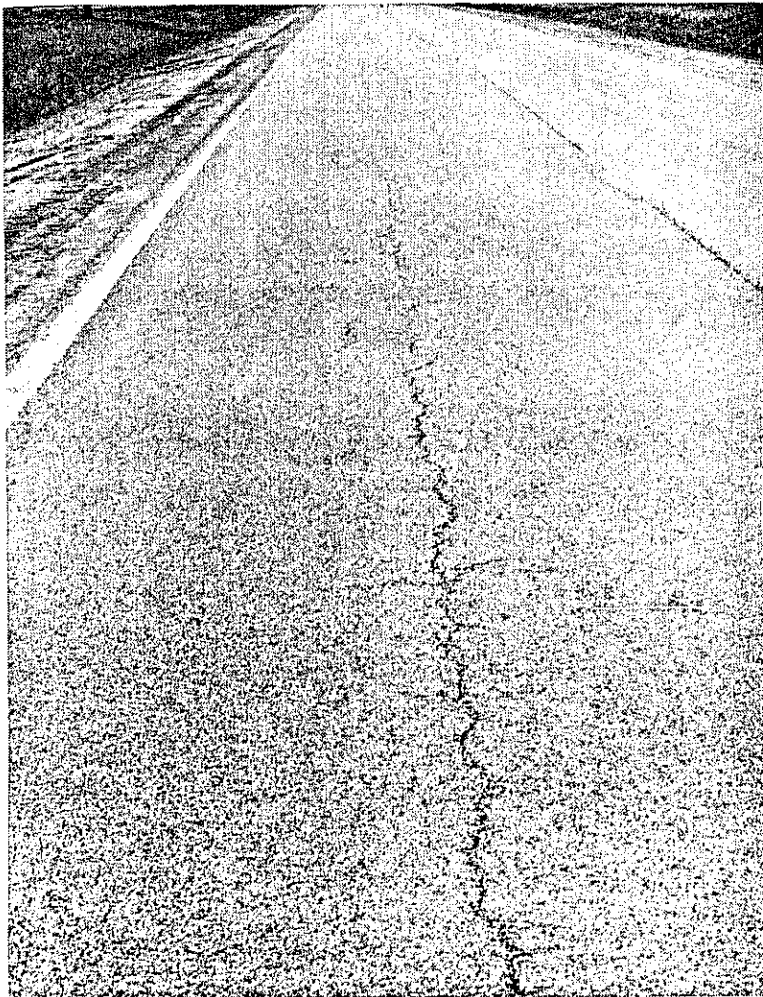
FIGURE 12: MID-LANE
LONGITUDINAL CRACKING IN
4-INCH CRACK AND SEAT
SECTION ON ILLINOIS
ROUTE 97

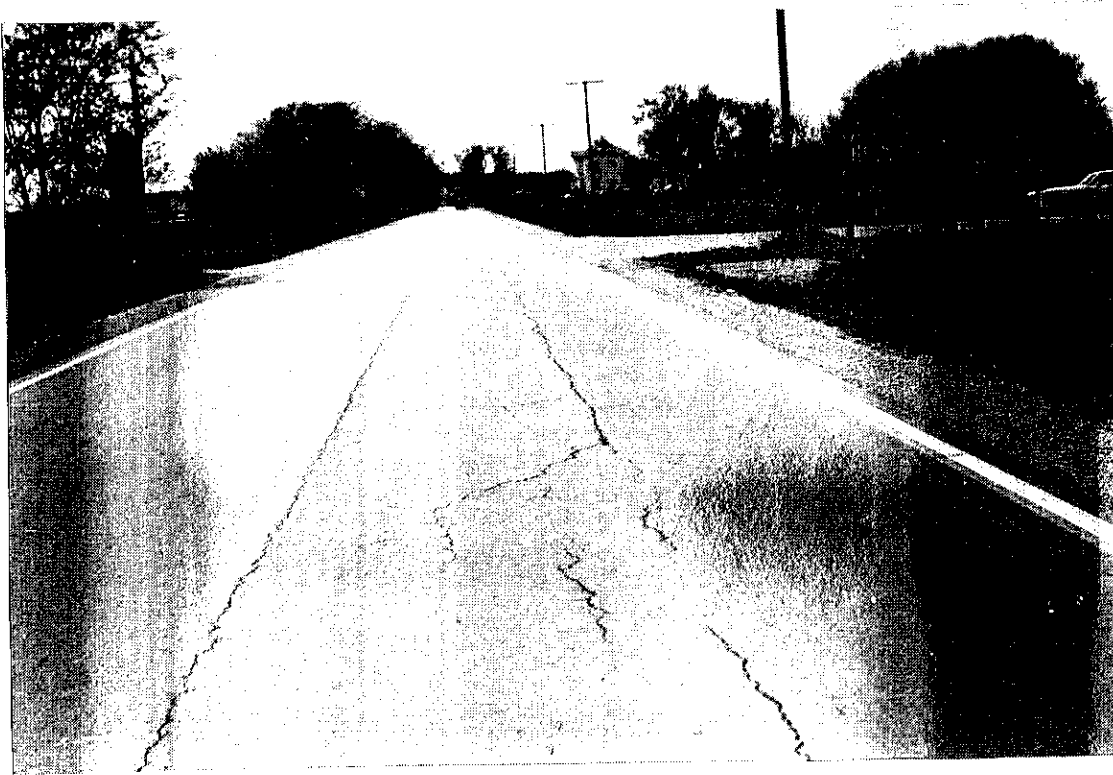
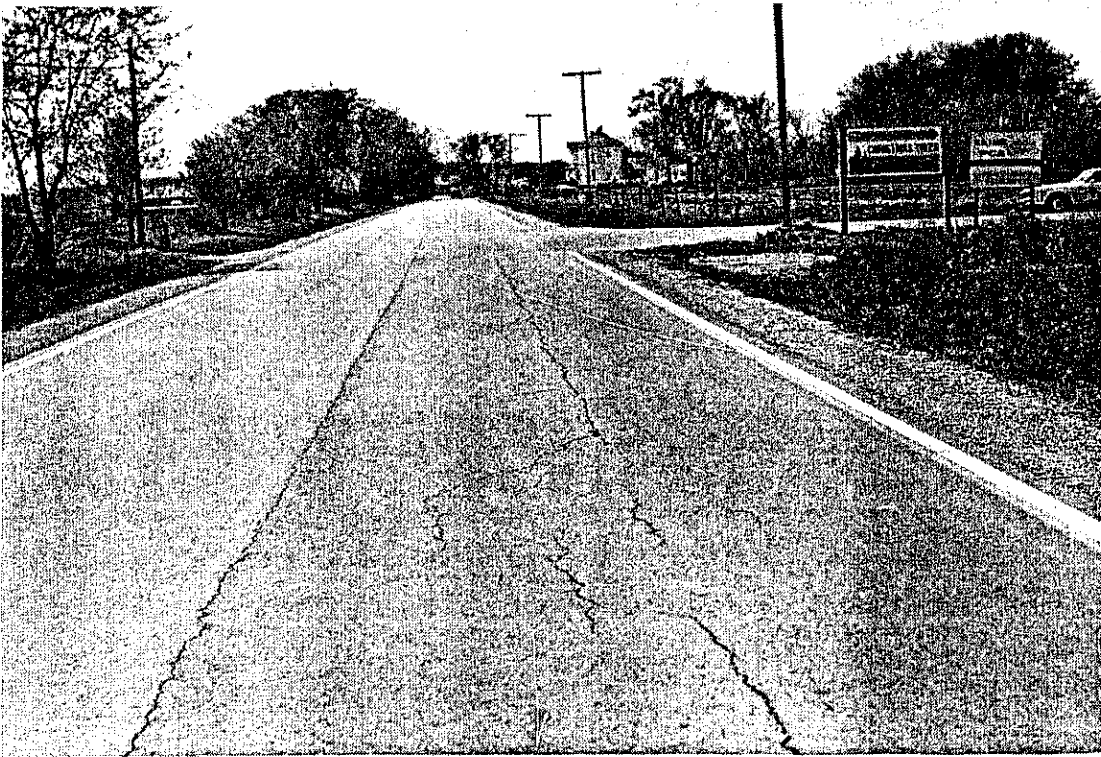
recorded in November 1986 in the 3-inch overlay section. However, such a simplistic comparison overlooks the fact that the 4-inch overlay section had a history of water problems and frost-susceptible soils. These conditions may also explain the increased longitudinal cracking found in the 4-inch overlay section, as shown in Figure 16.

FIGURE 16:
REFLECTIVE CRACKING IN
4-INCH SECTION ON
ROCKTON ROAD WITH
HISTORY OF WATER
PROBLEMS

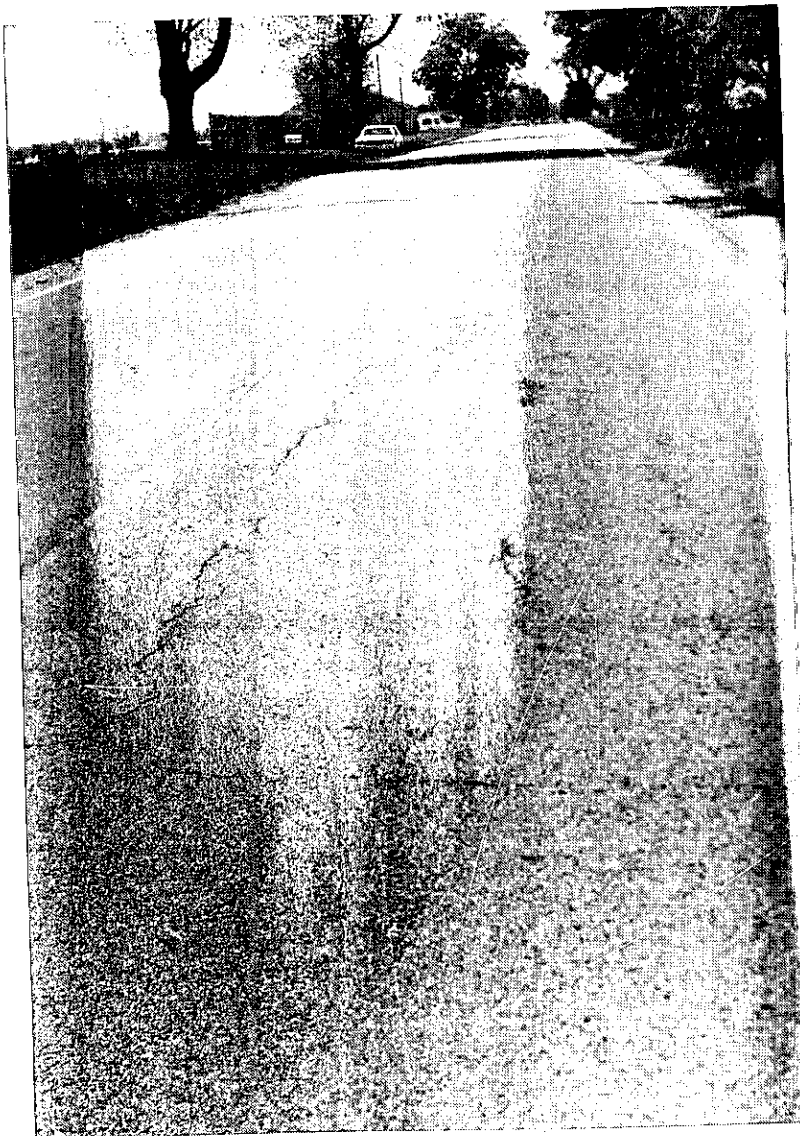
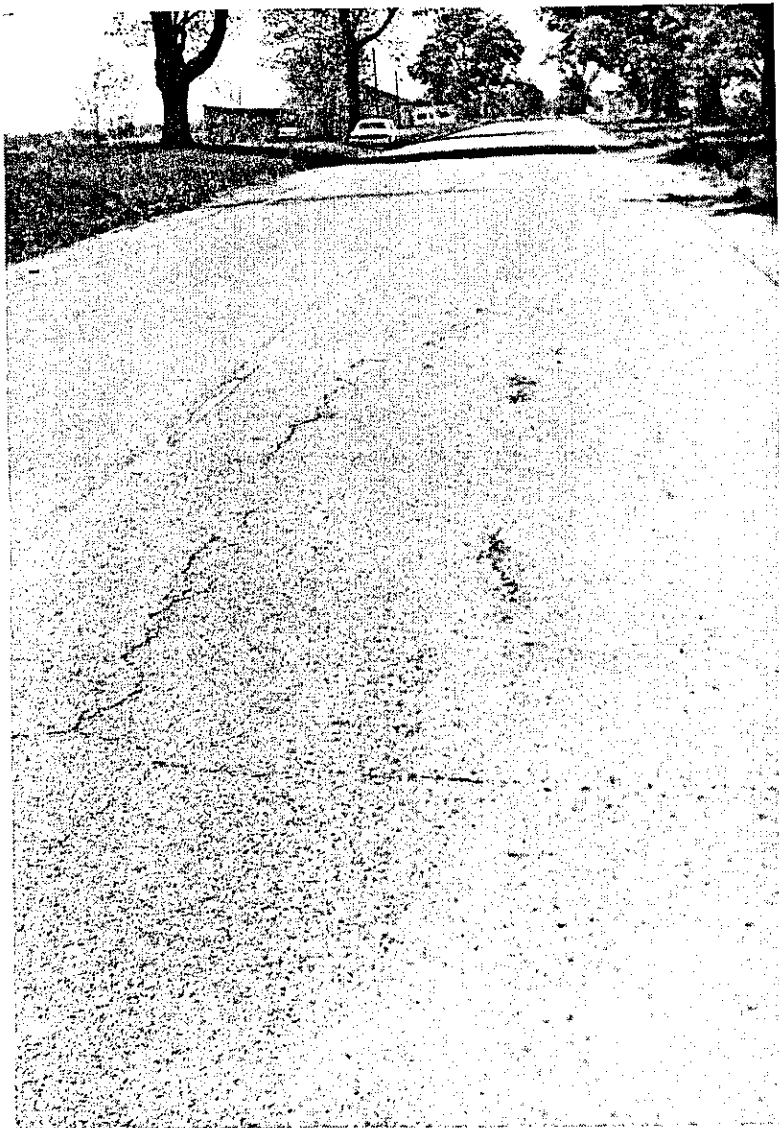
Two years after construction, both the 3 1/2-inch and the 4-inch overlays were in excellent condition. After the third year in service, both sections had an increase in transverse cracking and the 3 1/2-inch overlay experienced a large increase in longitudinal and widening cracking. Table 6 and Figure 18 illustrate this. To some extent the increase in cracking can be attributed to segregation in the asphalt concrete overlay mixture, as can be seen in Figure 17. The open texture of the mix allows water infiltration and promotes crack formation.

FIGURE 17: REFLECTIVE CRACKING
AND SEGREGATION IN 3 1/2-INCH
CRACK AND SEAT SECTION ON
U. S. ROUTE 6

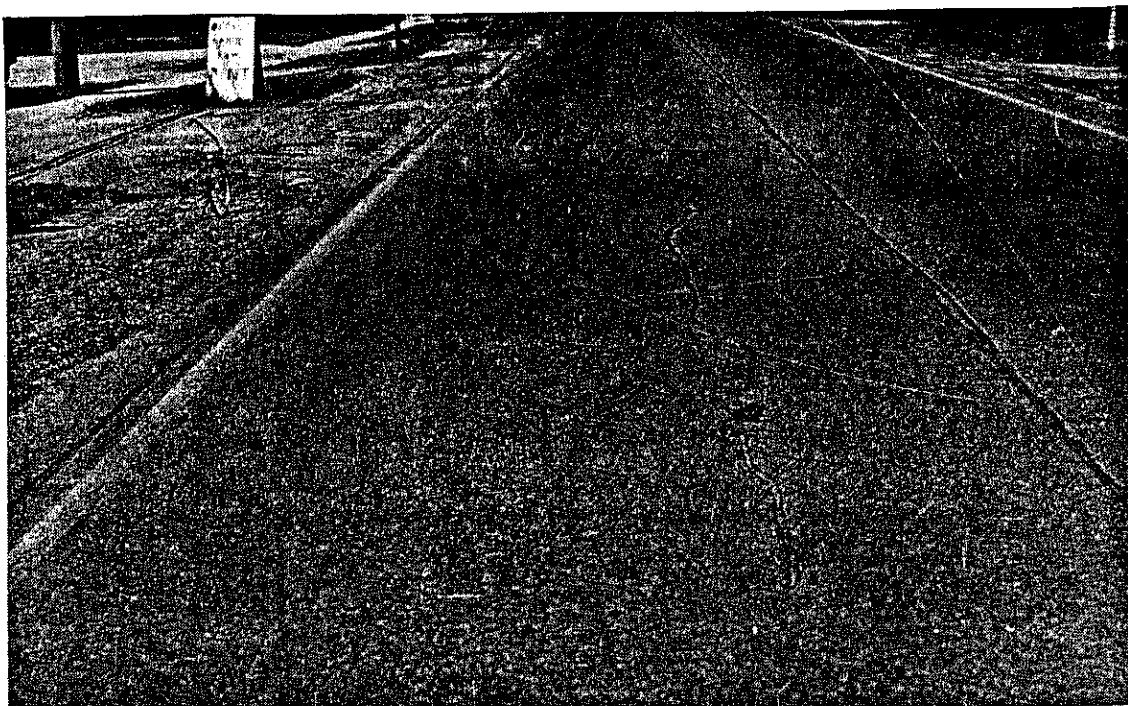
After five years in service, the crack and seat section seems to be performing well. While not directly comparable to the control section due to differences in overlay thickness, cracking and seating did significantly reduce the amount of transverse cracking, as can be seen in Table 2 and Figure 8. There was a slight increase in the amount of longitudinal cracking shown in Figure 9, which may be attributable to the type of pavement breaker used and the crack pattern it produced. Other states have noted that continuous longitudinal cracking should be avoided due to its tendency to reflect through the overlay (2). Prior to the last survey, all the cracks had been routed and sealed.

FIGURE 9: LONGITUDINAL CRACKING ON LINCOLN
TRAIL CRACK AND SEAT SECTION
